CAMERON ENGINEERING REPORT NO. 9A-CR3-580A-31

ENVIRONMENTAL EFFECTS ON 580A, 581A & 583A DIFFERENTIAL PRESSURE SWITCHES

| APPROVED BY 9-29-92 | | ENVIRONMENTAL EFFECTS ON THE 580 SERIES SWITCHES |

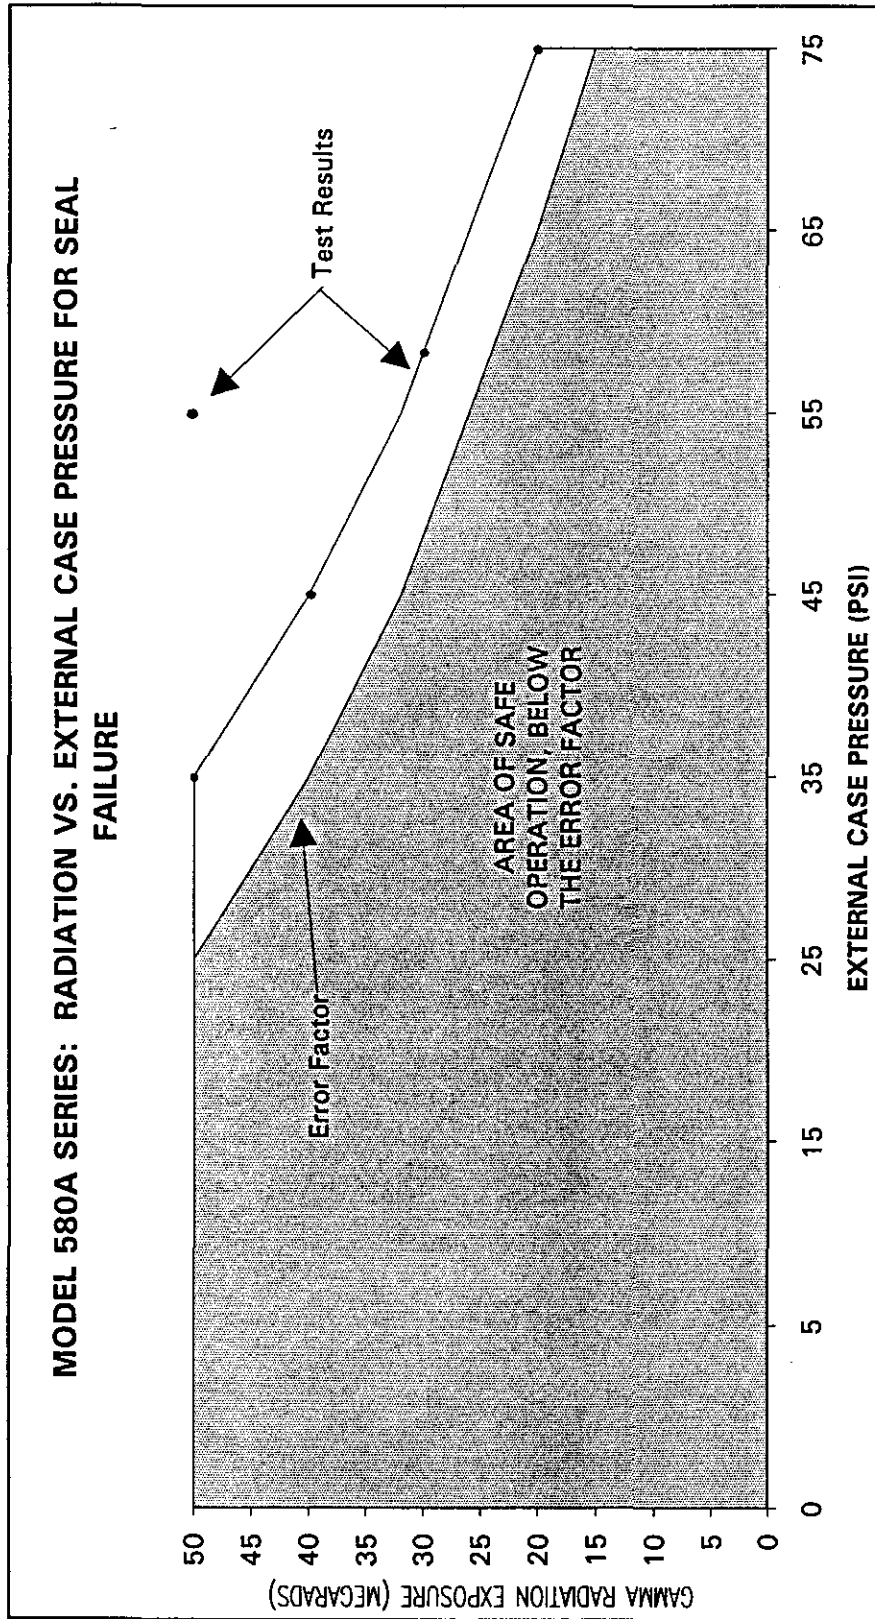
FIGURE 1

The following conclusions are based on the information derived from a limited number of test instruments. The graph (Figure 1), provided as a part of this report, showing radiation exposure relative to external case pressure to cause seal failure, is predicated on a single instrument exposed to each radiation level, with the exception of 50 megarads where two instruments were radiated. The second 50 megarad unit withstood approximately 33% more pressure, indicating that radiation vs pressure is not an exact relationship, although the other radiation test points are consistent with the curve. For conservatism, an arbitrary error factor has been applied on the graph by reducing the withstand pressure 10 psi at each radiation exposure level to allow for possible instrument variations. As may be seen on the graph, the integrity of the seal remains intact up to an exposure of 20 megarads when the case is subjected to the 75 psi maximum external pressure. When applying the error factor, the pressure is reduced to 65 psi and, if projected, the 580 Series instruments will withstand the full 75 psi after exposure to 15 MR. Conversely, they will withstand 25 psi external pressure after exposure to 50 MR of radiation.

The switch setpoints at each case pressure are the average of three successive runs where repeatability and deadband were predominantly less than 0.5% with no indication of blackout between the switch contacts. Case deflections were obtained for Engineering information only, to determine correlation between the movement of the rear surface relative to seal leakage. The amount of deflection varied between 0.021" to 0.055" when the case was exposed to 75 psi external pressure with accompanying radiation levels from 0 to 20 megarads. The torque tube seal remained intact. At radiation levels from 30 to 50 megarads and 0.0215" to 0.032" deflections, there were seal failures, confirming the Figure 1 graph.

After reaching the required 75 psi with no indication of seal failure, the test was terminated on both non-radiated instruments. The units to be subjected to nuclear radiation were transported to Radiation Sterilizers, Inc. in Tustin, California, where they were exposed to Gamma sources of Cobalt⁶⁰ at an approximate dose rate of 2×10^6 RADS/Hour. Each instrument was then installed in the test fixture and subjected to external pressure as described previously. The results of these tests are shown in Figure 1.

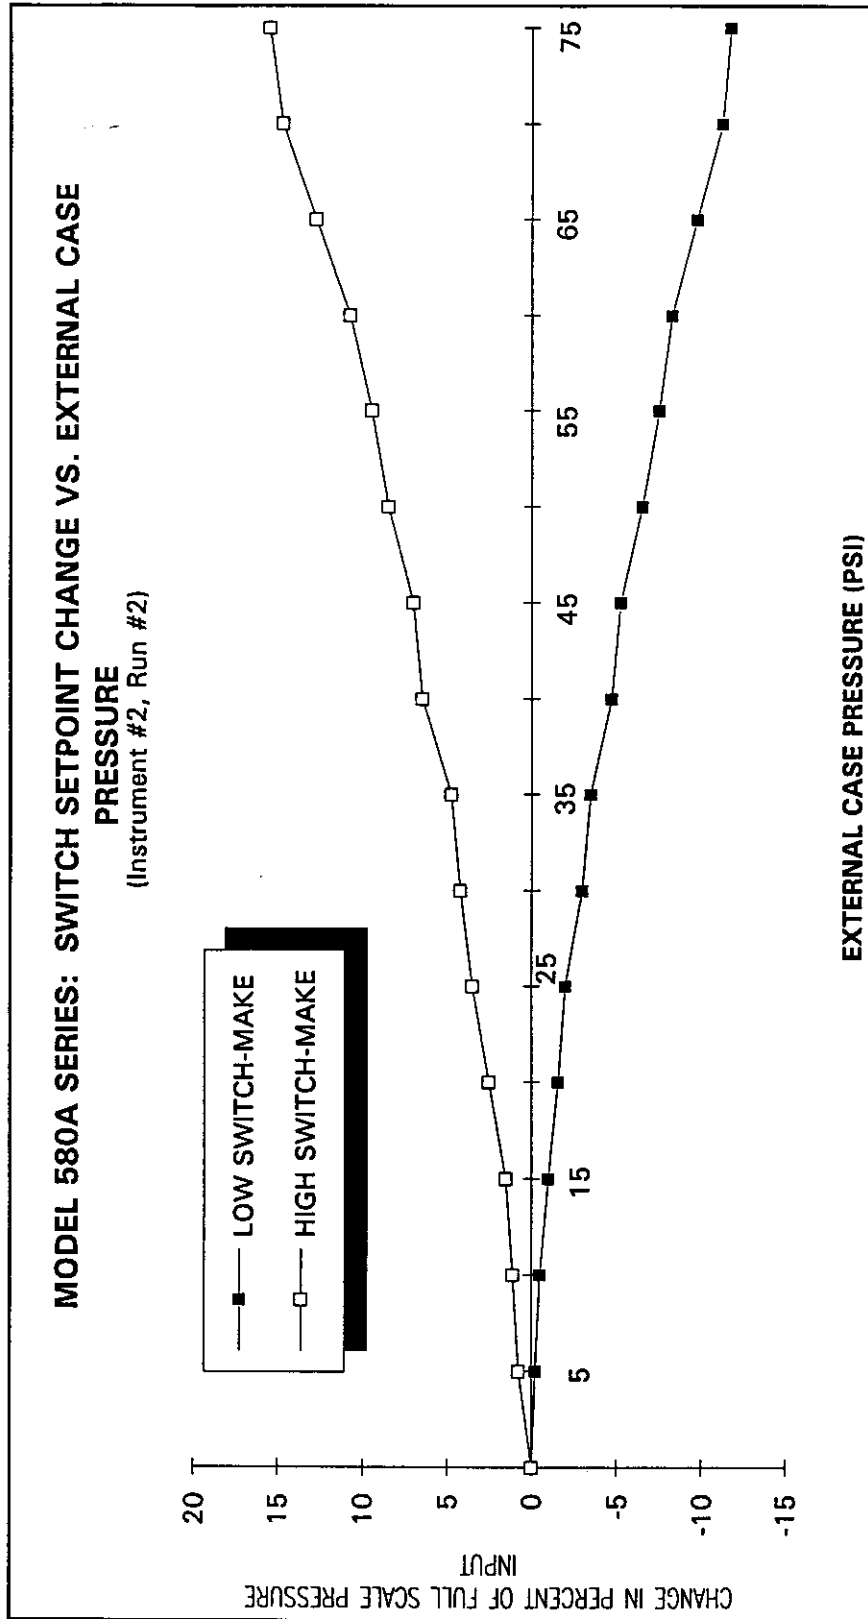
FIGURE - 2

The second objective, as required by Test Procedure 9999-32672 (Attachment A), is a determination of switch setpoint changes relative to the application of external case pressure. Referring to Figures 2 and 3, indicates that in both instruments, the low switch setpoint decreased, while the high switch setpoint increased as the pressure advanced. The setpoint changes, attributable to deflection of the rear of the case, reached maximums of - 11.8% for the low switch and + 15.4% for the high switch at 75 psi external pressure on one instrument per Figure 2 and -8.3% low switch, + 16.7% high switch on the second unit Per Figure 3.

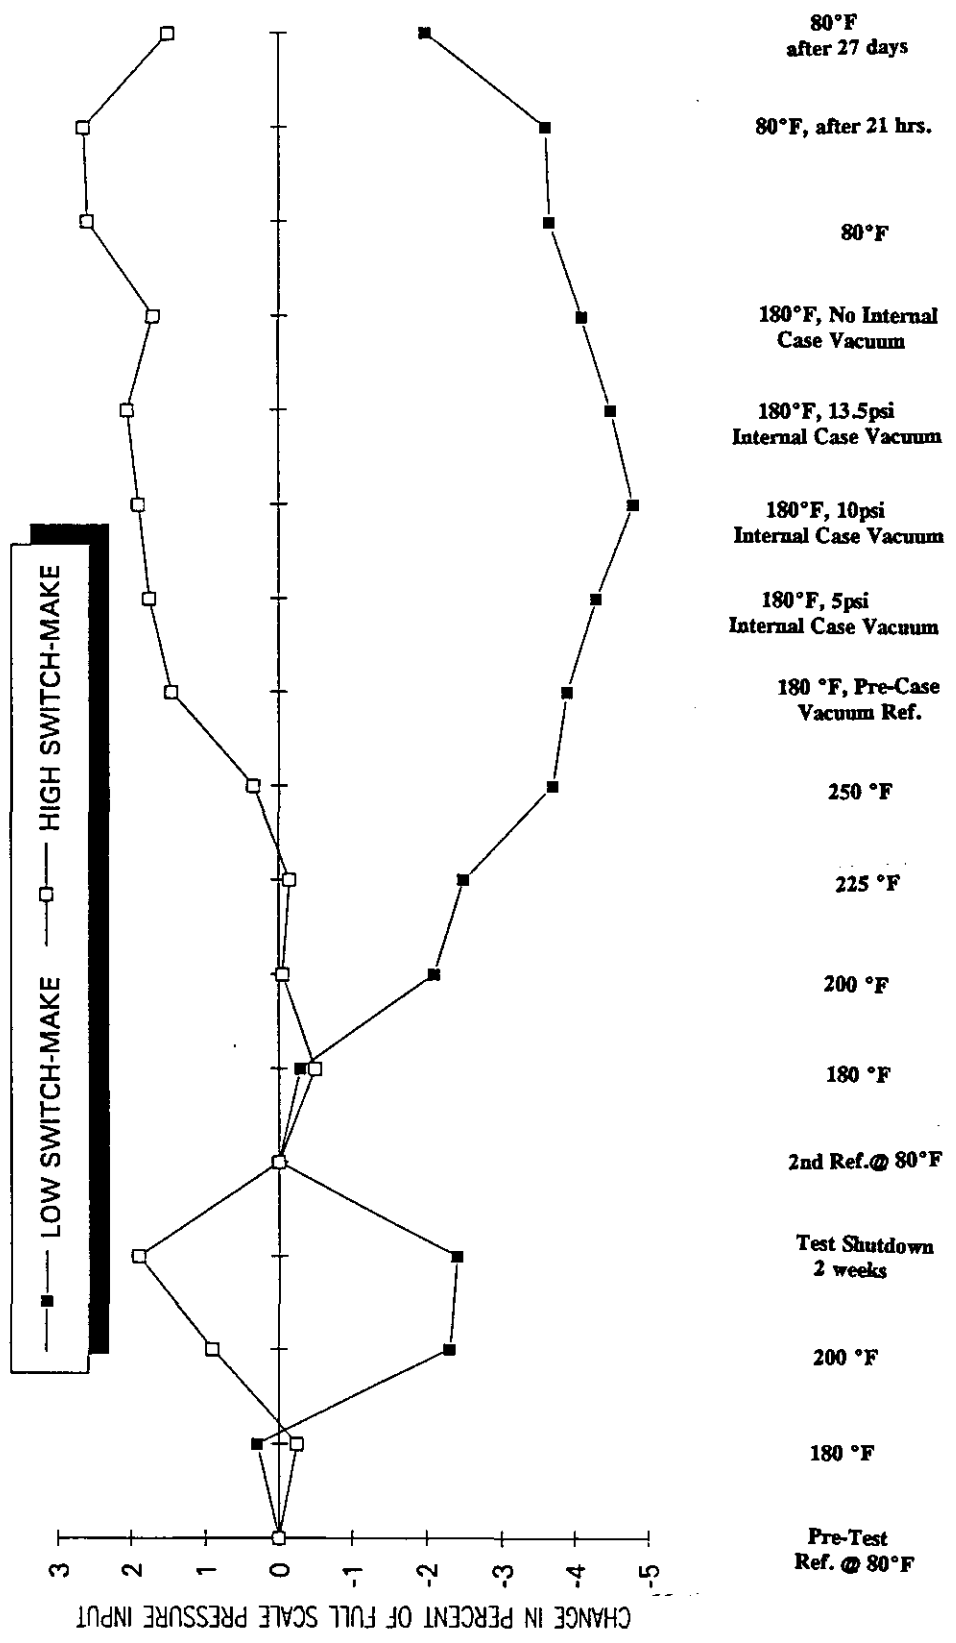
FIGURE 4

The testing which was conducted at various temperatures and internal case vacuum, simulating external pressure, indicated that these conditions were not a factor. The instruments remained within the allowable $\pm 10\%$ setpoint error band when exposed to temperatures as high as 250°F and when subjected to simultaneous case pressures up to 15 psi. The torque tube seal remained intact under all exposures, as shown in Figures 4 and 5.

Measurements of switch setpoints were made at a temperature of + 80°F, then the chamber temperature was advanced sequentially to 180°F, 200°F, 225°F and 250°F where setpoints were checked at each level. Vacuum was next applied to the case at 180°F to determine if there were any synergistic effects. Refer to Figures 4 and 5 for the test results

MODEL 581A-844: SWITCH SETPOINT CHANGE VS. VARYING TEMPERATURES & INTERNAL CASE PRESSURES

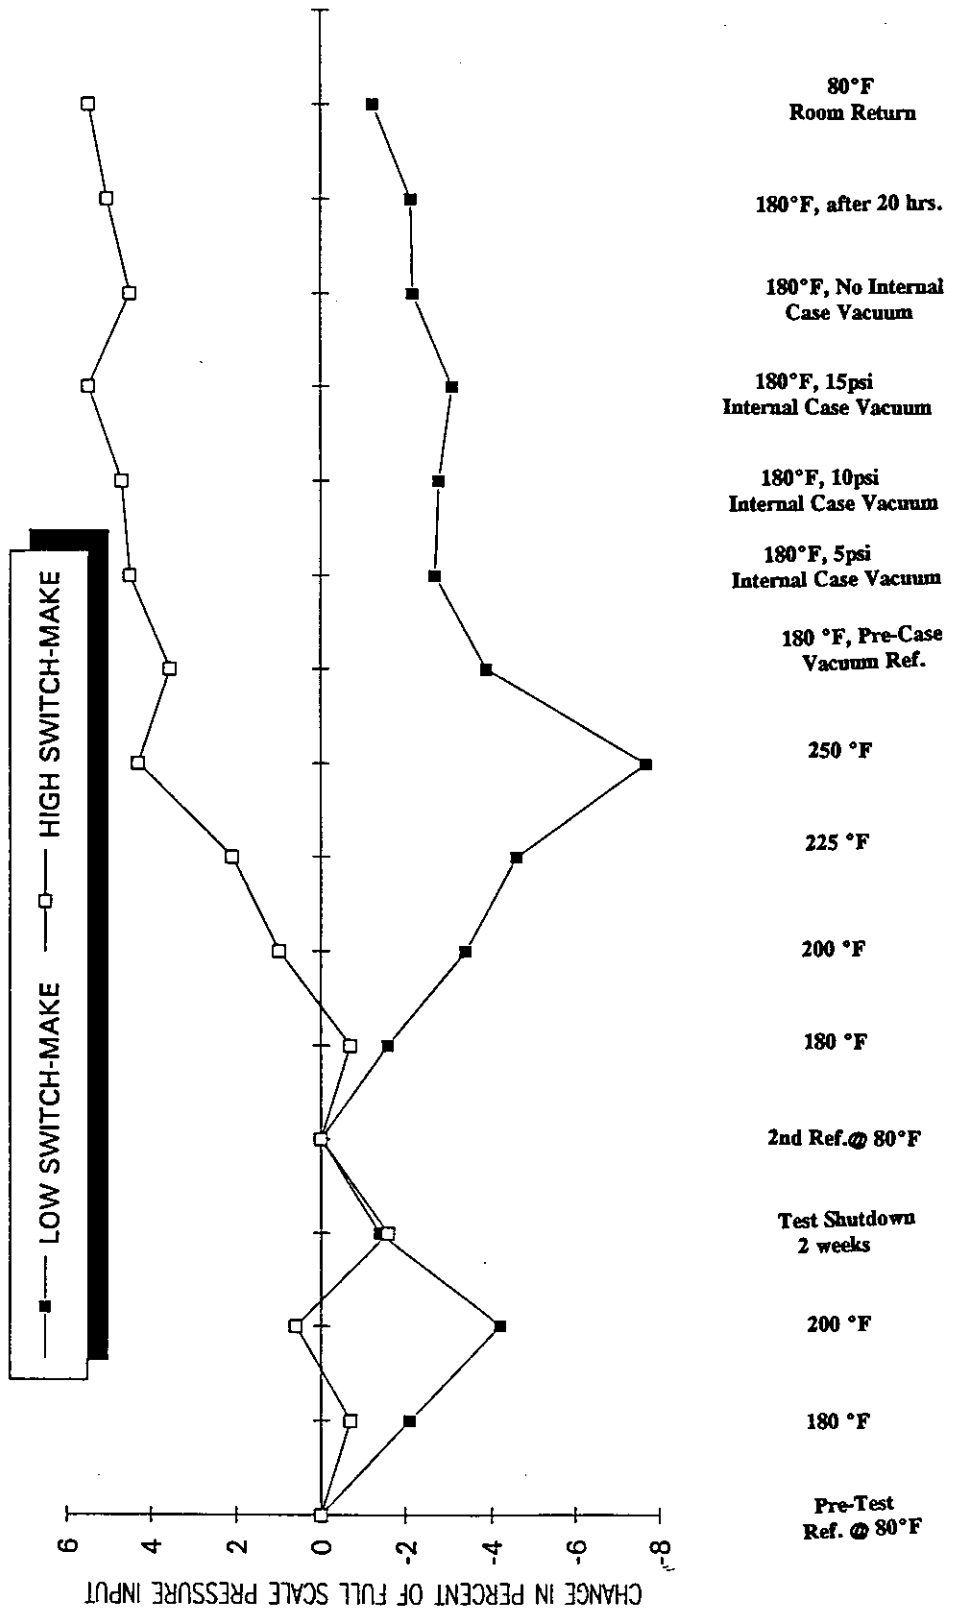
MODEL 580A-944: SWITCH SETPOINT CHANGE VS. VARYING TEMPERATURES & INTERNAL CASE PRESSURES
